Texas Freeze – Power Crisis Causes, Effects, Implications TX & Nationally

Agenda

1. Texas Power Grid (Texas Reliability Entity)
2. Texas Power Facts and Figures
3. ERCOT Real-time Data and Rising Wind
4. February 2021 Freeze
5. ERCOT's April 6, 2021, Preliminary Report
6. Report on 2011 Southwest Cold Weather Event

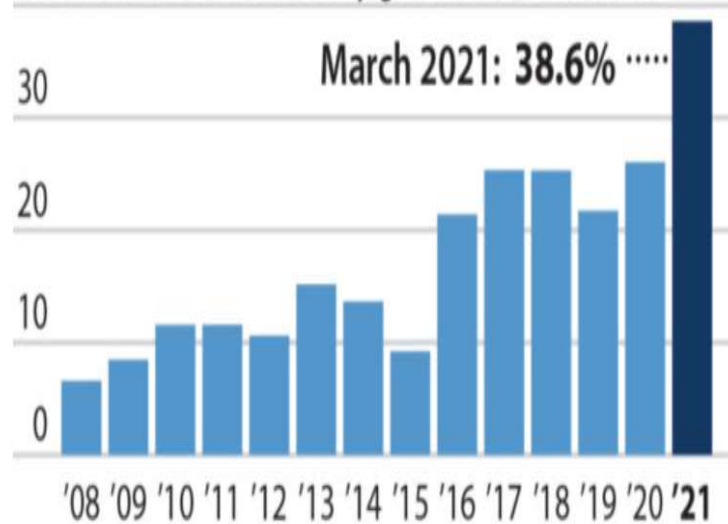
ERCOT: Wind's Market Share Surges in March

40% share of total electricity generation each March

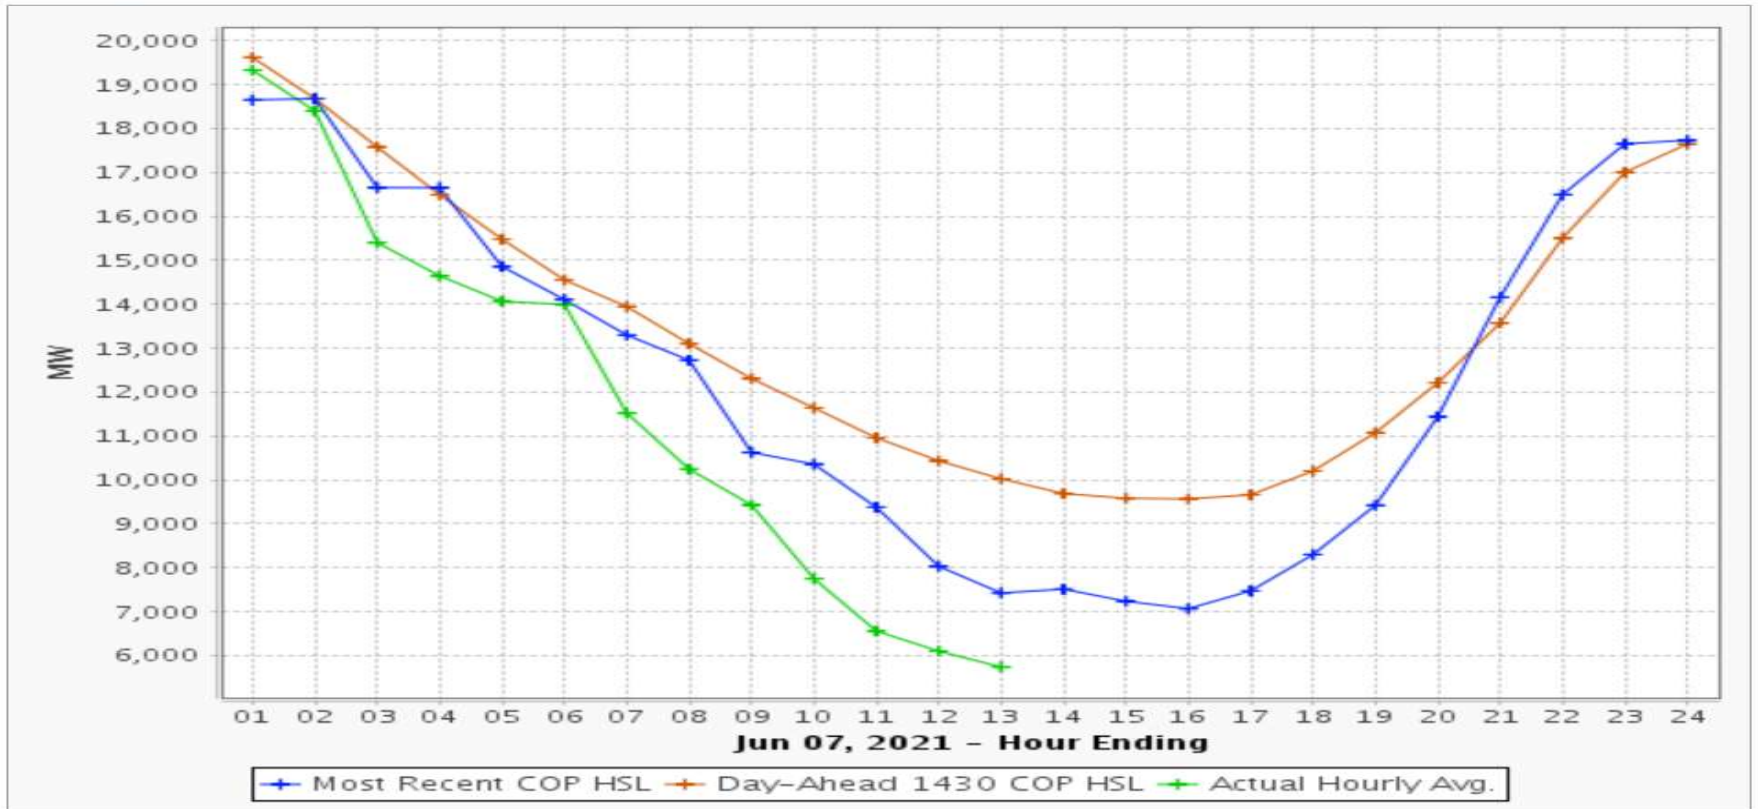
COP HSL for Current Day Forecasted and Actual Wind Power Production

Wind Power Production: 5,637 MW
Updated: Jun 07, 2021 14:30

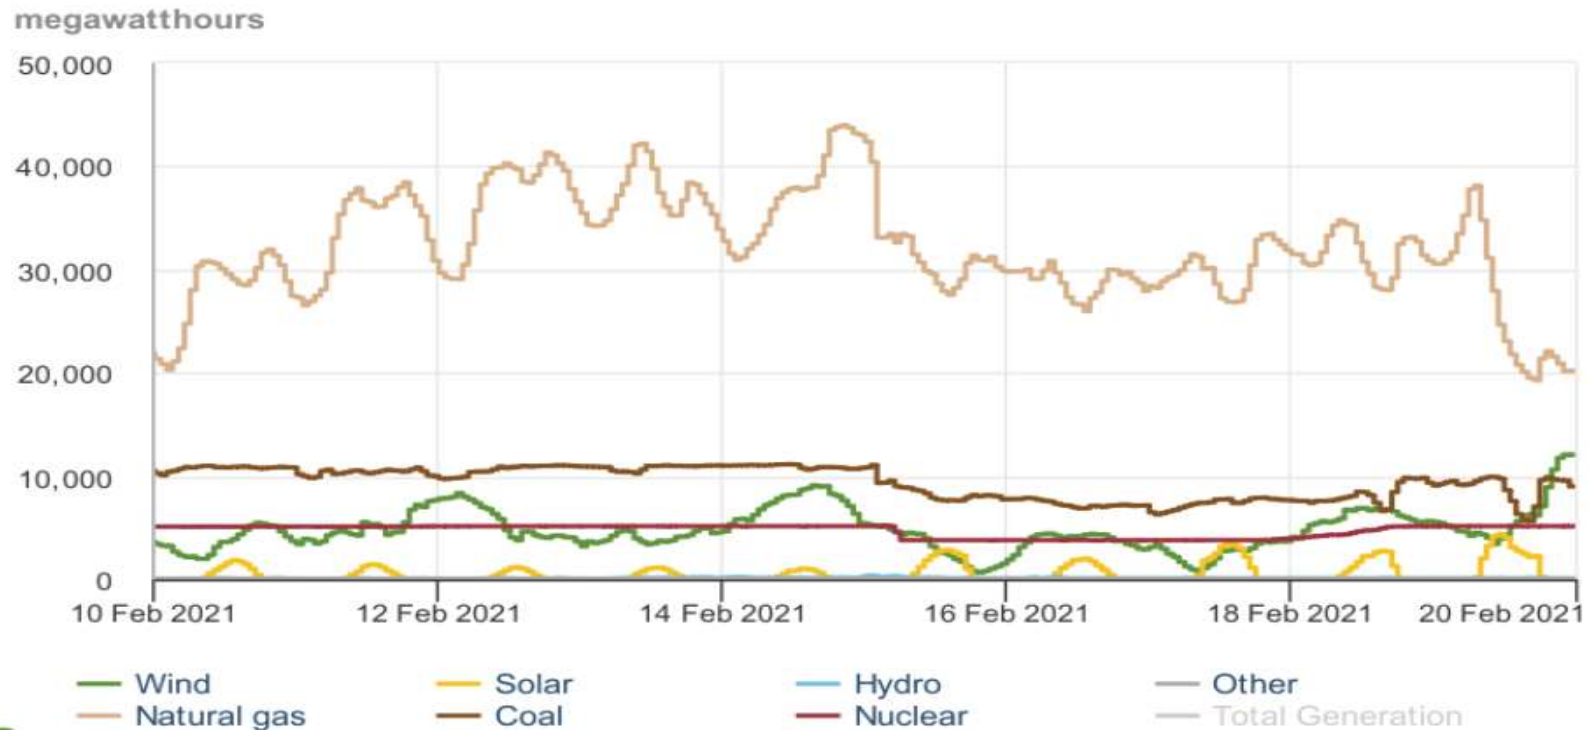
FIGURE 5: TEXAS ELECTRICITY GENERATION BY SOURCE DURING TEXAS OUTAGES

Electric Reliability Council of Texas, Inc. (ERCOT) electricity generation by energy source 2/10/2021 – 2/19/2021, Central Time

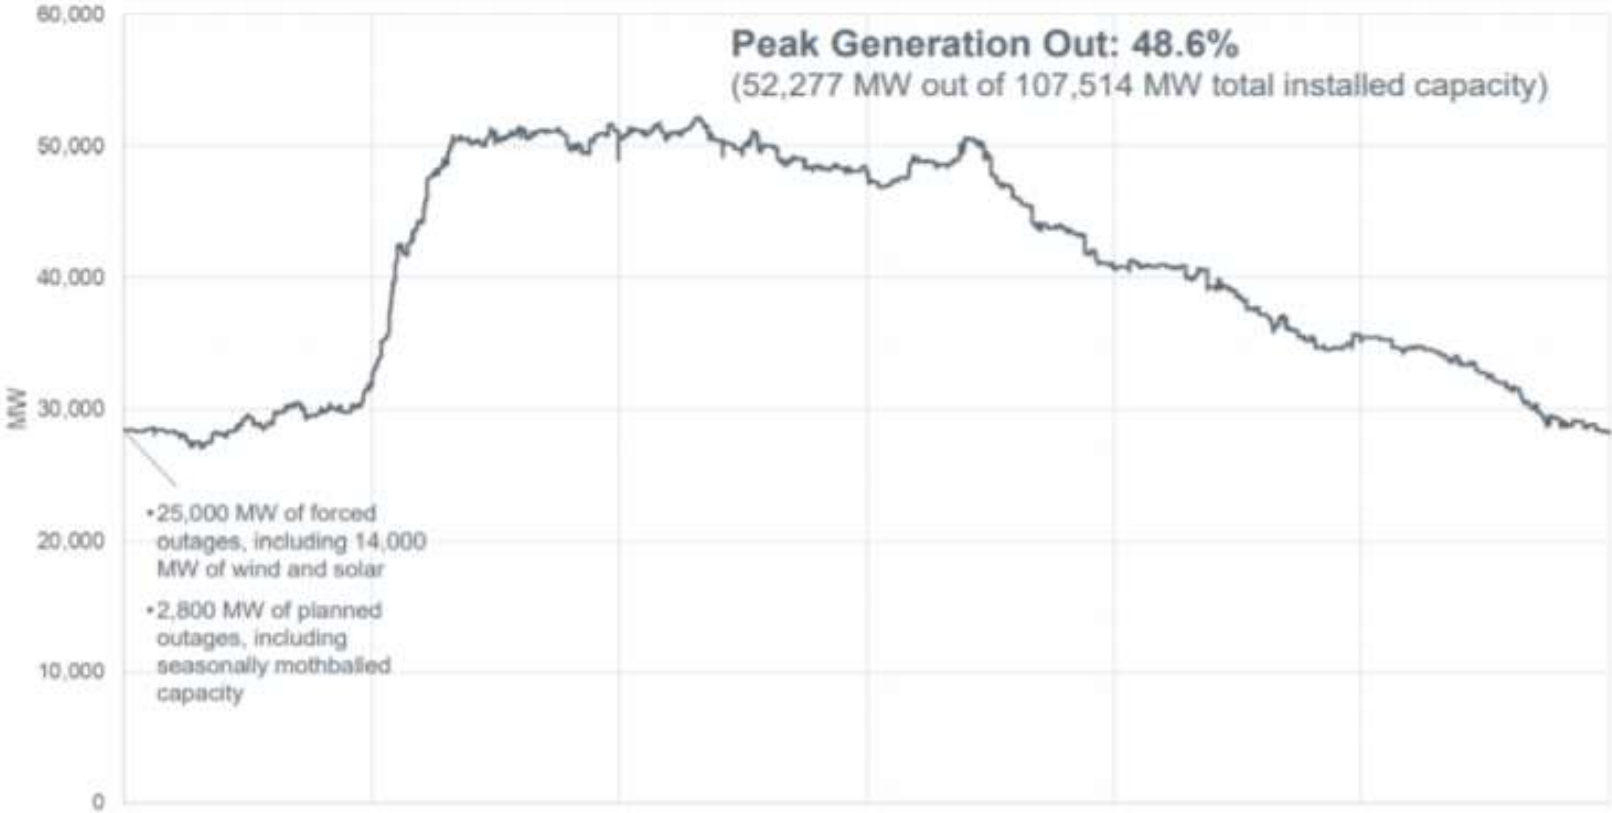
Generation Capacity Out

- ▶ “It appears that a lot of the generation that has gone offline today has been primarily due to issues on the natural gas system,” Woodfin said Tuesday, noting that thermal sources accounted for nearly double the number of gigawatts offline compared with renewable sources like wind.

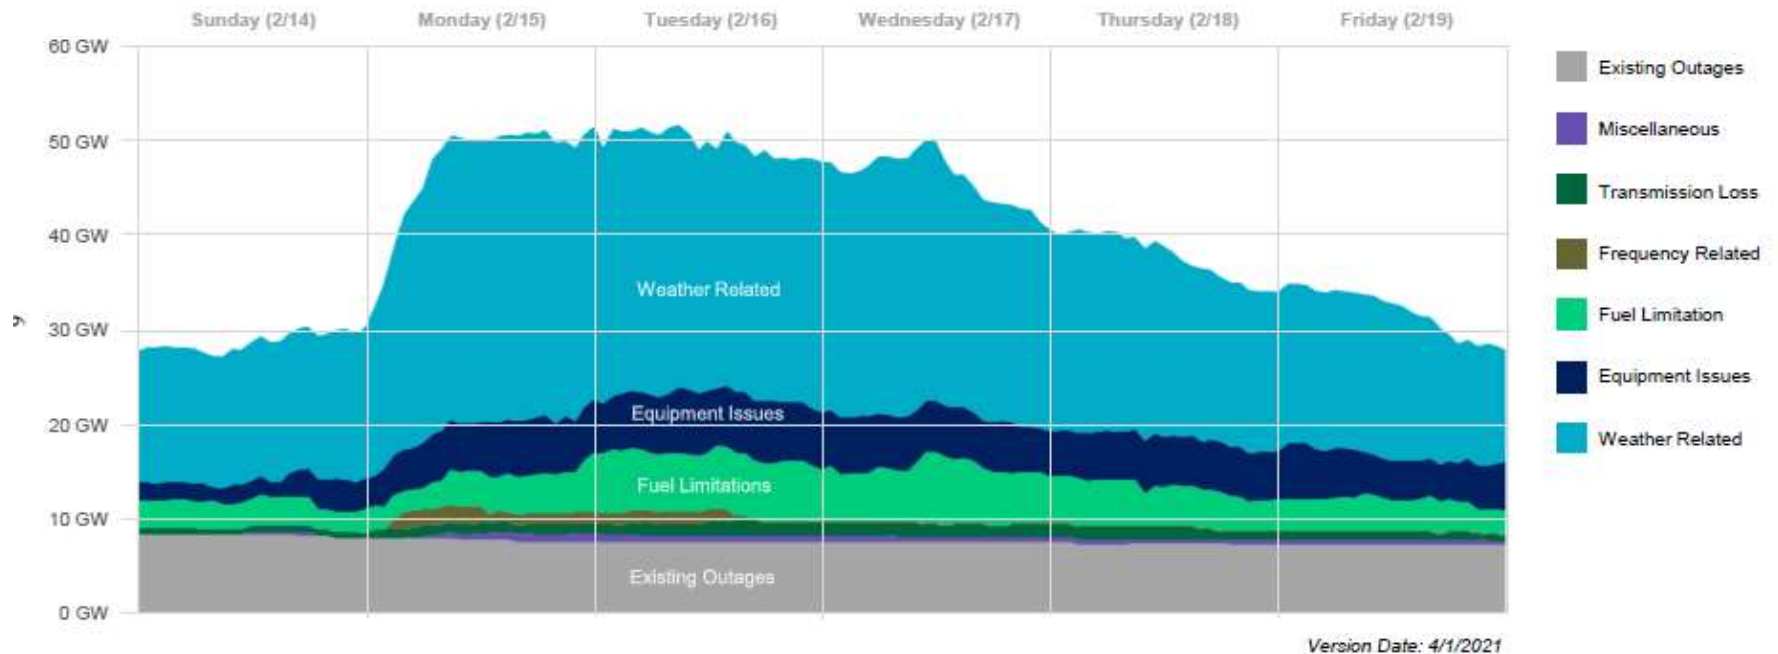
Net Generator Outages and Derates by Cause (MW)

February 14 – 19, 2021

Net generator outages at the beginning of each hour on February 14-19, 2021, by cause category.

- ▶ **Existing Outages:** Generator outages or derates that started before the issuance of the Operating Condition Notice on February 8, 2021; includes ongoing planned and forced outages as well as seasonally mothballed units. Some existing outages ended before or during the event, allowing the unit to return to service.

- ▶ **Weather Related:** Generator outages or derates explicitly attributed to cold weather conditions in the RFI responses. This includes but is not limited to frozen equipment—including frozen sensing lines, frozen water lines, and frozen valves—ice accumulation on wind turbine blades, ice/snow cover on solar panels, exceedances of low temperature limits for wind turbines, and flooded equipment due to ice/snow melt.

- ▶ **Equipment Issues:** Generator outages or derates due to facility equipment failures or malfunctions not explicitly attributed to cold weather in the RFI response. This includes trips and derates related to control system failures, excessive turbine vibrations, or other equipment problems.
- ▶ **Transmission Loss:** Generator outage or derates due to forced outages on directly connected transmission facilities.
- ▶ **Frequency Related:** Generator outage or derates attributed to frequency deviations from 60Hz; includes automatic tripping due to under-frequency protection relays and any automatic or manual tripping attributed to plant control system issues related to frequency deviation.
- ▶ **Miscellaneous:** Other generator outages or derates not linked to one of the above causes, including outages for which a cause is yet unknown.
